**DEPARTMENT OF TRANSPORTATION**

Contract #: 04-0120F4Cty: SF/ALA Rte: 80 PM: 13.2/13.9File #: 69.28**WELDING INSPECTION REPORT****Resident Engineer:**Pursell, Gary**Address:** 333 Burma Road**City:** Oakland, CA 94607**Report No:** WIR-001690**Date Inspected:** 23-Feb-2008**Project Name:** SAS Superstructure**OSM Arrival Time:** 1830**Prime Contractor:** American Bridge/Fluor Enterprises, a JV**OSM Departure Time:** 730**Contractor:** Zhenhua Port Machinery Company, Ltd (ZPMC), Changxing Island **Location:** Shanghai, China**CWI Name:** Chen Xi**CWI Present:** Yes No**Inspected CWI report:** Yes No N/A**Rod Oven in Use:** Yes No N/A**Electrode to specification:** Yes No N/A**Weld Procedures Followed:** Yes No N/A**Qualified Welders:** Yes No N/A**Verified Joint Fit-up:** Yes No N/A**Approved Drawings:** Yes No N/A**Approved WPS:** Yes No N/A**Delayed / Cancelled:** Yes No N/A**Bridge No:** 34-0006**Component:** OBG**Summary of Items Observed:**

Caltrans Quality Assurance (QA) Inspector, Mike Hasler was present to observe the fitup, welding and related activities associated with the fabricating of Caltrans Mock-up, 77M, 89M, 114M and the orthotropic box girders (OBG), for the San

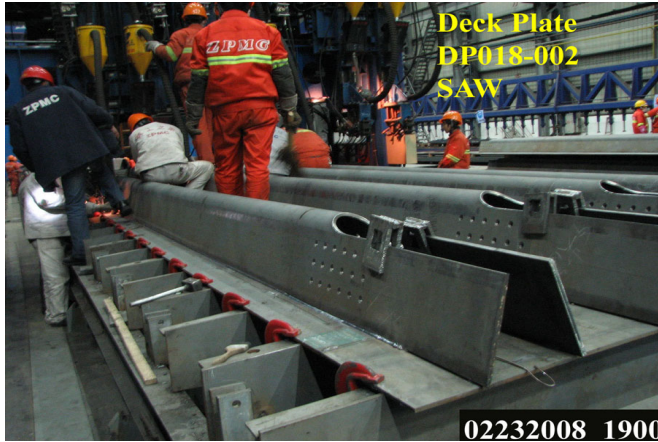
OBG Bay 1--Production Monitoring: Caltrans QA Inspector observed the closed rib welding on Deck Plates DP-018-002.

Submerged arc welding (SAW) is being performed at gantry 2. The deck panel is a carry-over from the day shift which had completed the gas metal arc welding (GMAW) of the root pass weld. Caltrans QA observed that the welding was being monitored by ZPMC Quality Control (QC)/ Certified Welding Inspector (CWI), Mr.Chen Xi. The Saw welding was completed at 2130. The following digital picture illustrates SAW in progress.

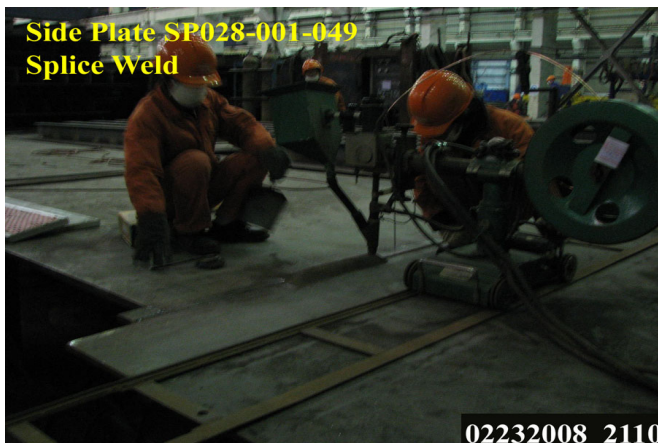
2 plate na na welding in progress

Bay 7: Caltrans QA Inspector observed submerged arc welding (SAW), plate splice weld, side plate identified as SP028-001 weld #49. Caltrans QA observed ZPMC QC/CWI inspector, Mr. Chih Ming Chen monitoring welding activities at the work-station. Mr. Chih Ming Chen stated that welder is identified as #046830 welding in accordance with welding procedure specification WPS-B-T-2221-B-L2-S-1, Revision 0. Caltrans QA Inspector measured current welding parameters at approximately 500 amps, 30.0 volts and 455 millimeters per minute (mm/min) travel speed. The interpass temperature was verified during welding and measured less than 232 Celsius (450 degrees Fahrenheit). The SAW welding consumable is identified as EM12K- JW-3, flux JF-B and diameter 4.8mm. The following digital pictures illustrate welding in progress.
